CLVT- , *PPB*  
Brooks Log House , ruin  
Island Creek Vicinity  
Private

INVENTORY FORM FOR STATE HISTORIC SITES SURVEY

HISTORIC Brooks House, ruin, or Brooks Log House

STREET & NUMBER South side of the east fork of Ben's Creek Rd, 0.5 mile east of its jct. with Williams' Wharf Rd.

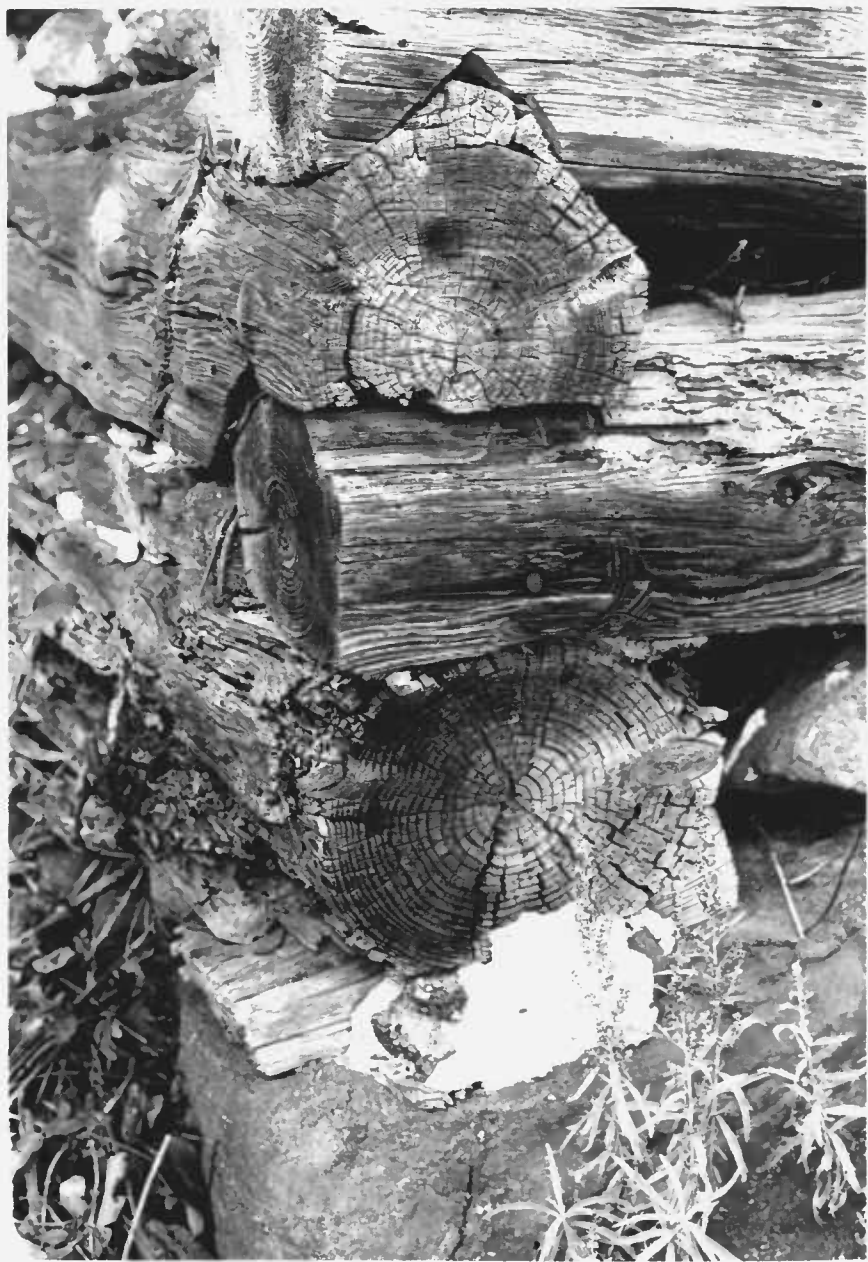
The house is two stories in height, the first floor being log, and the second, frame. The first floor appears to be the original section, with the second added at some time, most likely near the turn of the century. The log block is three bays in length, arranged in bilateral symmetry. The house is one bay in depth. In terms of structural features, the log walls rest on ferrous sandstone pilings, are V-notched at the corners, and are sheathed with weatherboards attached to vertical boards over the logs, the boards serving the purpose of studs on frame houses, except that they bear no weight. One of the interesting features of the construction of this house is that it shows the wedges which were inserted between the corners of the log sills and the stone pilings in order to maintain a level floor. Also, the window opening on the east gable end is notched down into the log member, and the window frame set into this <sup>notch</sup>, the frame then serving as a kind of brace. (The slide of that wall shows this clearly.)

Detail of top

corner w/  
wedge ~~bar~~

between STONE  
+ SILL.
